**VENEZUELA COMMUNITY WASTEWATER AND STORMWATER
COLLECTION SYSTEMS**

Reconnaissance Inspection: Puerto Rico Aqueduct and Sewer Authority (PRASA) Puerto
Nuevo Regional Wastewater Treatment Plant (RRWTP) NPDES
Permit (PR0021555)

Autonomous Municipality of San Juan (MSJ) Municipal Separate
Storm Sewer System (MS4)
National Pollutant Discharge Elimination System (NPDES) Permit
(PRR040036)

Inspection Date: June 2, 2015

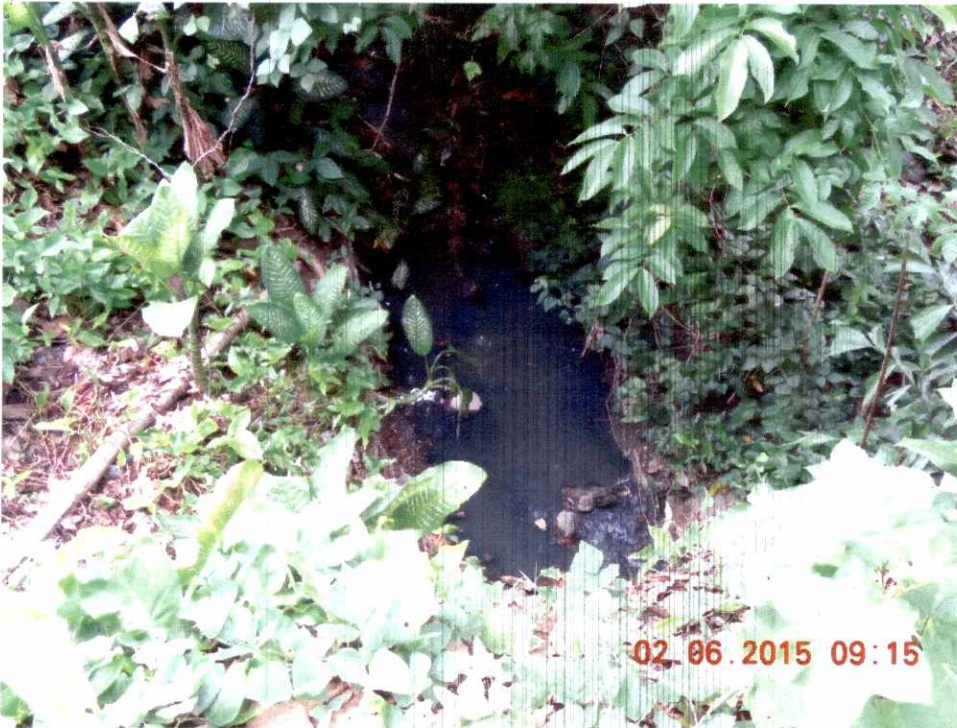
1. An unnamed creek was found with wastewater characteristics (e.g., odor, color, and algae formation) and flowing in direction of the Río Piedras River. The EPA inspector observed the unnamed creek from a location south of the University of Puerto Rico Botanical Garden and adjacent to the Botanical Garden Security Offices. Coordinates: Lat. 18° 23' 37.44" N – Long. 66° 3' 20.22" W. See photo DSCN2221 located in **Attachment I** for more details. Refer to EPAs May 26, 2015 RI Report for more details and photos of the discharge point into the Rio Piedras River.

DSCN2221 – Partial view of an unnamed creek was found with wastewater characteristics (e.g., odor, color, and algae formation) and flowing in direction of the Río Piedras River. The EPA inspector observed the unnamed creek from a location south of the University of Puerto Rico Botanical Garden and adjacent to the Botanical Garden Security Offices.

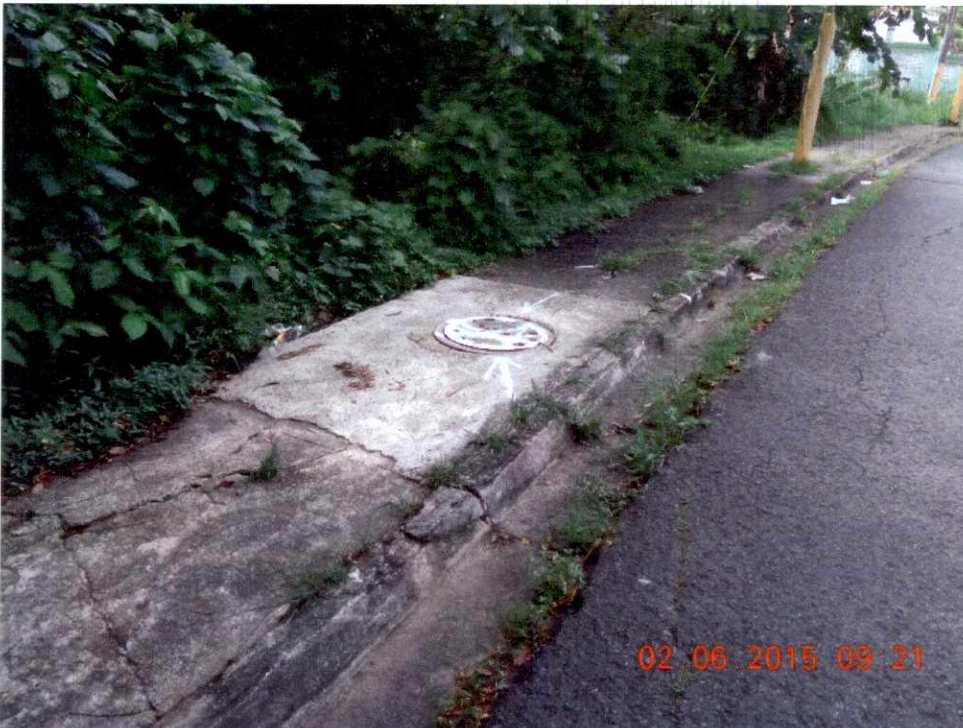
2. The wastewater manhole that was documented overflowing by the SJBEP on May 22, 2015 and included as part of EPA May 26, 2015 inspection documentation, was found flowing normally. The wastewater manhole is located at Venezuela's Guaracanal Street (PR-847), south of La Experimental Residential Development Street #1. Coordinates: Lat. 18° 23' 27.71" N – Long. 66° 3' 8.84" W. See photos DSCN2222 thru DSCN2224 located in **Attachment I** for more details. Refer to EPA May 26, 2015 RI Report for more details about the SJBEP May 22, 2015 findings.

DSCN2222 – View of a wastewater manhole that was documented overflowing by the SJBEP on May 22, 2015 and included as part of EPA May 26, 2015 inspection documentation, was found flowing normally. The wastewater manhole is located at Venezuela's Guaracanal Street (PR-847), south of La Experimental Residential Development Street #1.

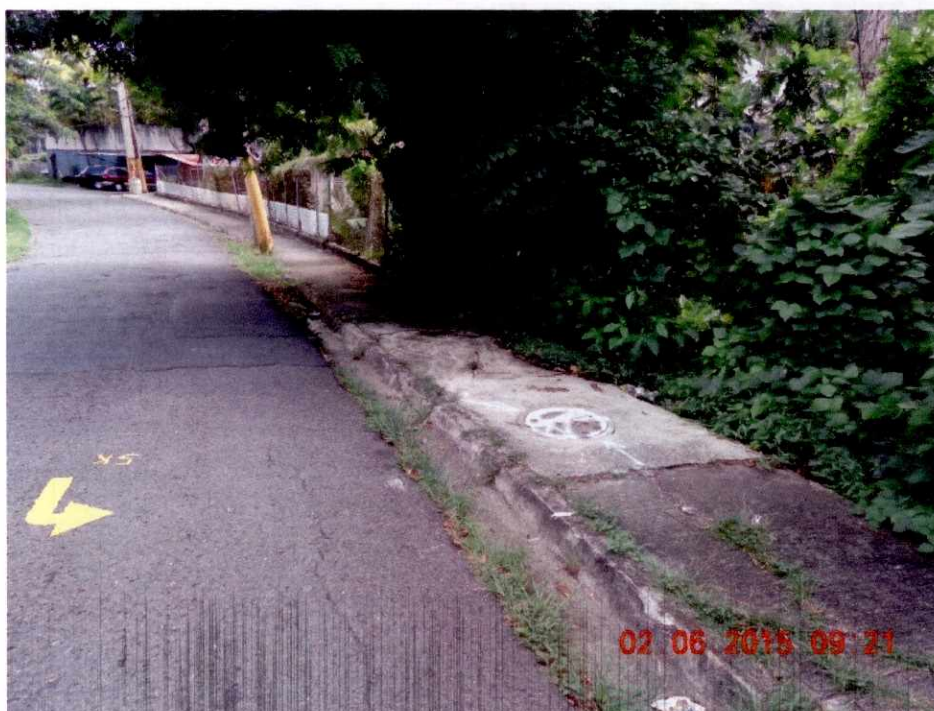
DSCN2223 – Additional view of a wastewater manhole that was documented overflowing by the SJBEP on May 22, 2015 and included as part of EPA May 26, 2015 inspection documentation, was found flowing normally. The wastewater manhole is located at Venezuela's Guaracanal Street (PR-847), south of La Experimental Residential Development Street #1.

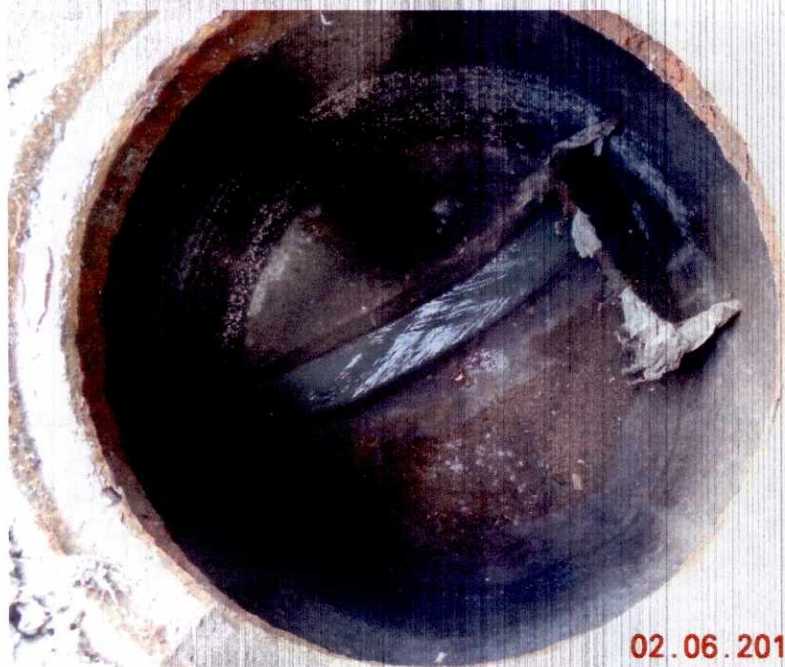
DSCN2224 – View of a inner part of the wastewater manhole is located at Venezuela's Guaracanal Street (PR-847), south of La Experimental Residential Development Street #1.

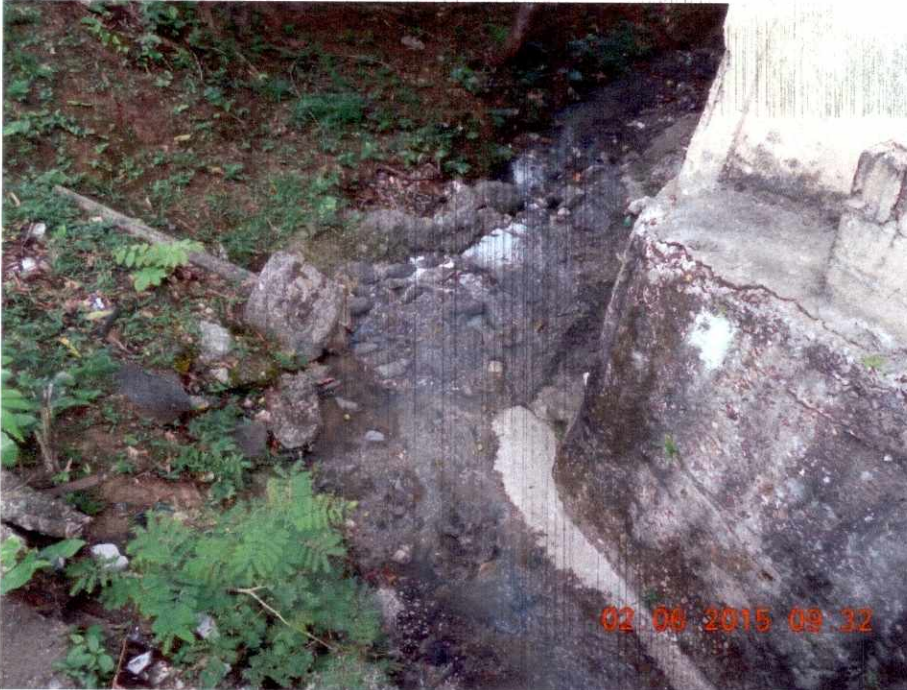
3. Significant amount of flow with wastewater characteristics (e.g., color, odor, solids, and algae formation) was observed in an unnamed creek located north of Venezuela's Amalia Marín Public School and south of Guaracanal (PR-847) and Izcoa Díaz Streets intersection. Coordinates: Lat. 18° 23' 36.68" N – Long. 66° 3' 15.72" W. See photos DSCN2225, DSCN2226, and DSCN2233 located in **Attachment I** for more details.

DSCN2225 – View of an unnamed creek located north of Venezuela’s Amalia Marín Public School and south of Guaracanal (PR-847) and Izcoa Díaz Streets intersection. Significant amount of flow with wastewater characteristics (e.g., color, odor, solids, and algae formation) was observed.

MSJ and PRASA shall take the necessary actions to cease discharging wastewaters into Waters of the United States. The response to this report shall include all the details, evidence, and results of such actions.

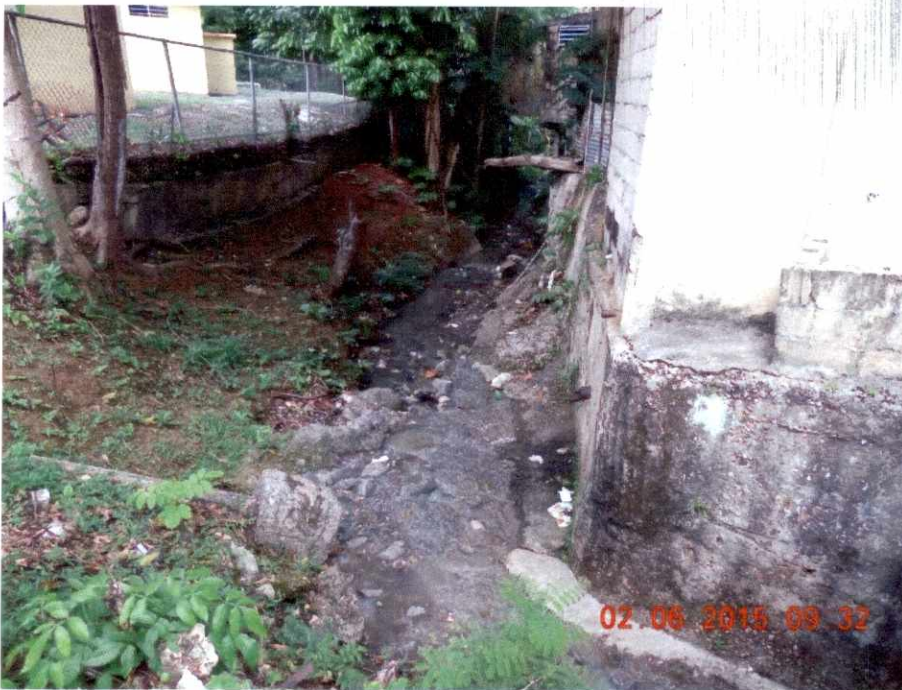
DSCN2226 – Additional view of an unnamed creek located north of Venezuela’s Amalia Marín Public School and south of Guaracanal (PR-847) and Izcoa Díaz Streets intersection. Significant amount of flow with wastewater characteristics (e.g., color, odor, solids, and algae formation) was observed.

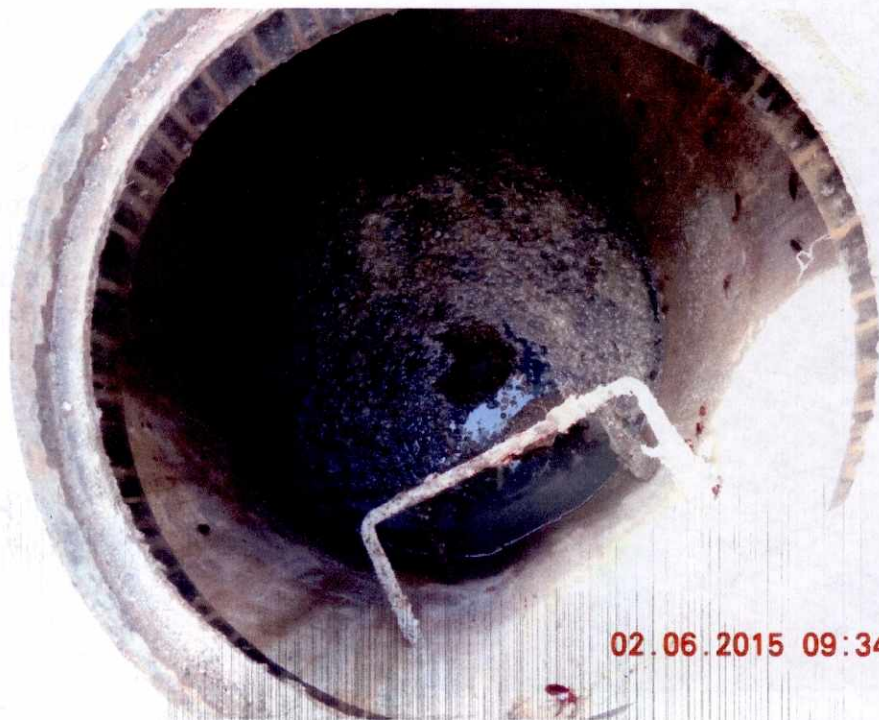
5. A wastewater manhole located at Guaracanal (PR-847) and Izcoa Díaz Street intersection was found with high levels of sewage. Coordinates: Lat. 18° 23' 37.02" N – Long. 66° 3' 15.80" W. See photos DSCN2227 and DSCN2228 located in **Attachment I** for more details.

DSCN2227 – View of the inner part of a wastewater manhole located at Guaracanal (PR-847) and Izcoa Díaz Street intersection. The wastewater manhole was found with high levels of sewage.

8. The EPA inspector contacted by telephone PRASA official Christie Mota, San Juan Operations Supervisor, and informed the preliminary inspection findings on June 2, 2015 via telephone at 10:01 AM. PRASA official Christie Mota informed the EPA inspector that PRASA suspects that the wastewater collection system segment that crosses the unnamed creek, described in item 3, could be the source of the wastewater discharges. In addition, Mrs. Mota stated that PRASA was in the process of coordinating a closed-circuit television (CCTV) camera study to determine the problem. Ms. Mota also added and alleged that a few days prior to the call PRASA was able to reduce the levels in the wastewater manhole described in item 5, and the discharge was eliminated temporarily.

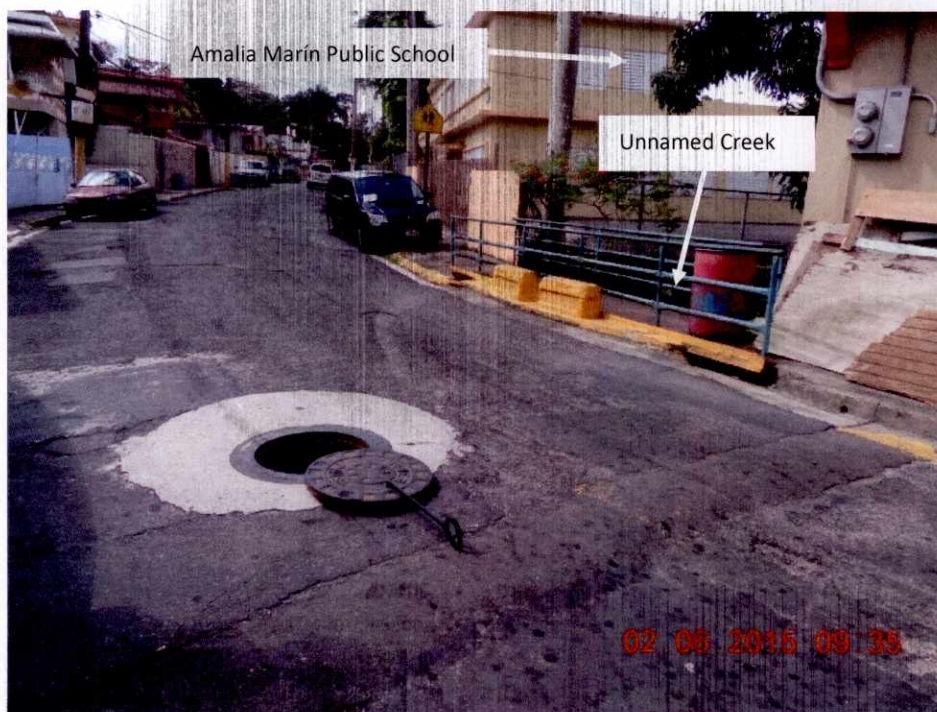
DSCN2228 – Additional view of a wastewater manhole located at Guaracanal (PR-847) and Izcoa Díaz Street intersection. The wastewater manhole was found with high levels of sewage.

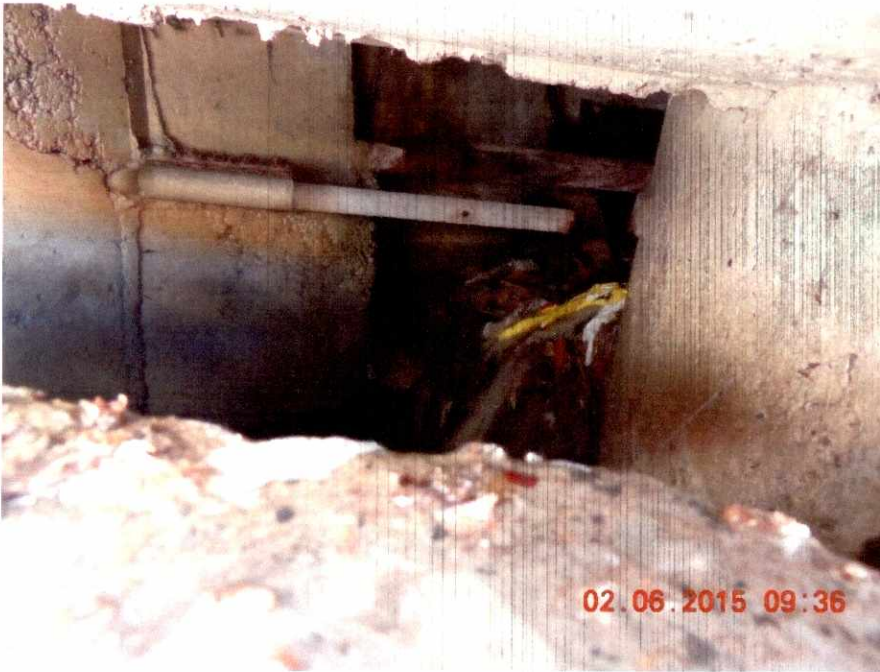
DSCN2229 – Partial view of the inner part of a stormwater inlet located near the Guaracanal (PR-847) and Izcoa Díaz Streets intersection. The inlet is located upstream of the unnamed creek found with wastewater presence.

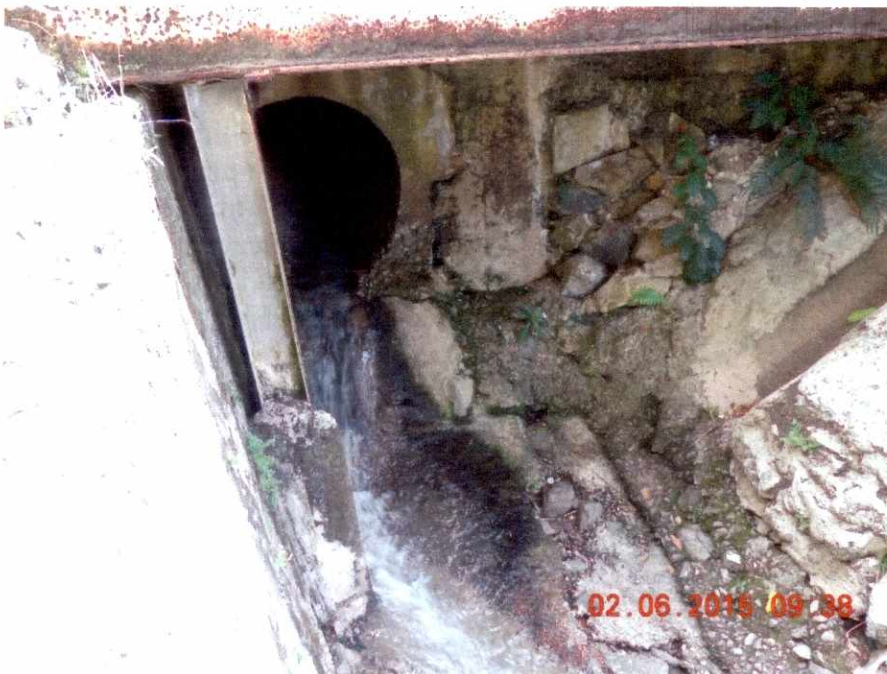
4. A concrete circular pipe of approximately 24 inches was found underneath Guaracanal Street (PR-847) and discharging significant amount of wastewater into the unnamed creek described in item 3. Coordinates: Lat. 18° 23' 36.72" N – Long. 66° 3' 15.73" W. See photos DSCN2230 to DSCN2232 located in **Attachment I** for more details.

DSCN2230 – View of a concrete circular pipe of approximately 24 inches was found underneath Guaracanal Street (PR-847) and discharging significant amount of wastewater into the unnamed creek described in photo DSCN2225 and DSCN2226.

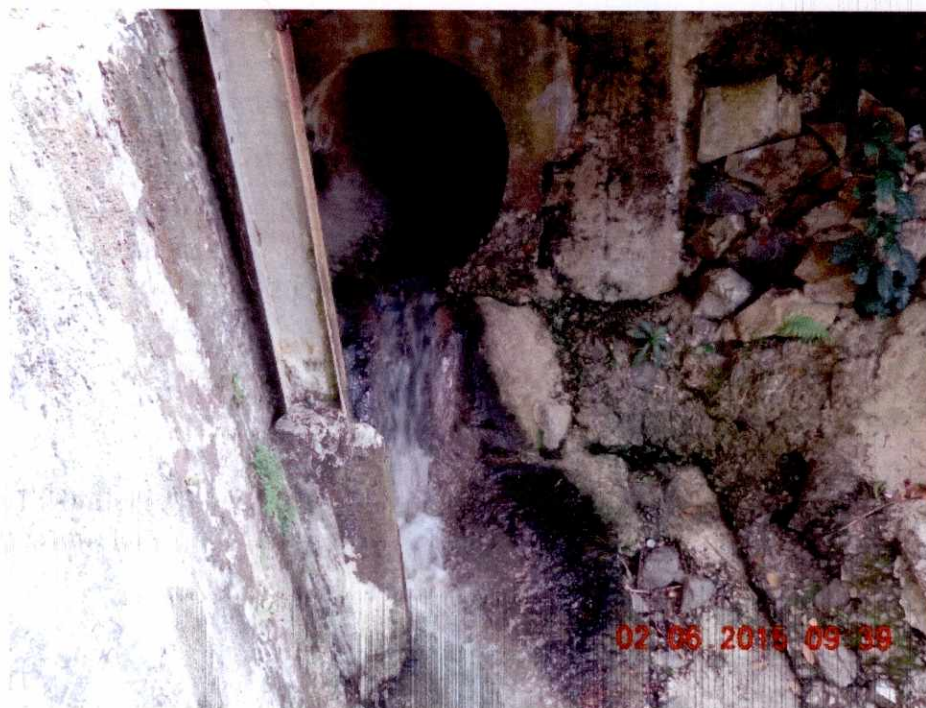
DSCN2231 – Additional view of a concrete circular pipe of approximately 24 inches was found underneath Guaracanal Street (PR-847) and discharging significant amount of wastewater into the unnamed creek described in photo DSCN2225 and DSCN2226.

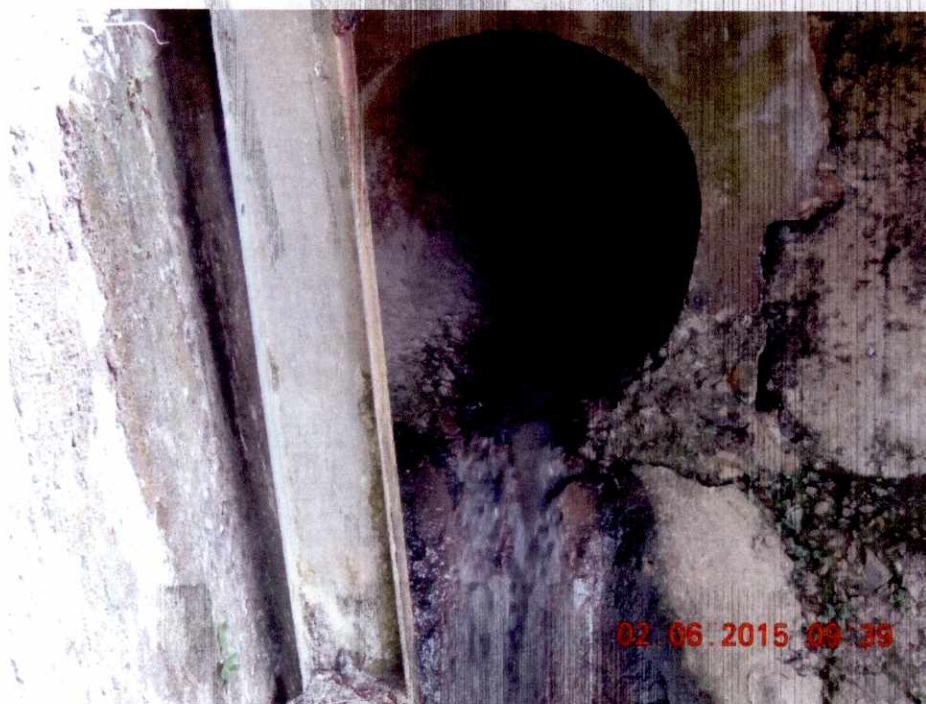
DSCN2232 – Additional view of a concrete circular pipe of approximately 24 inches was found underneath Guaracanal Street (PR-847) and discharging significant amount of wastewater into the unnamed creek described in photo DSCN2225 and DSCN2226.

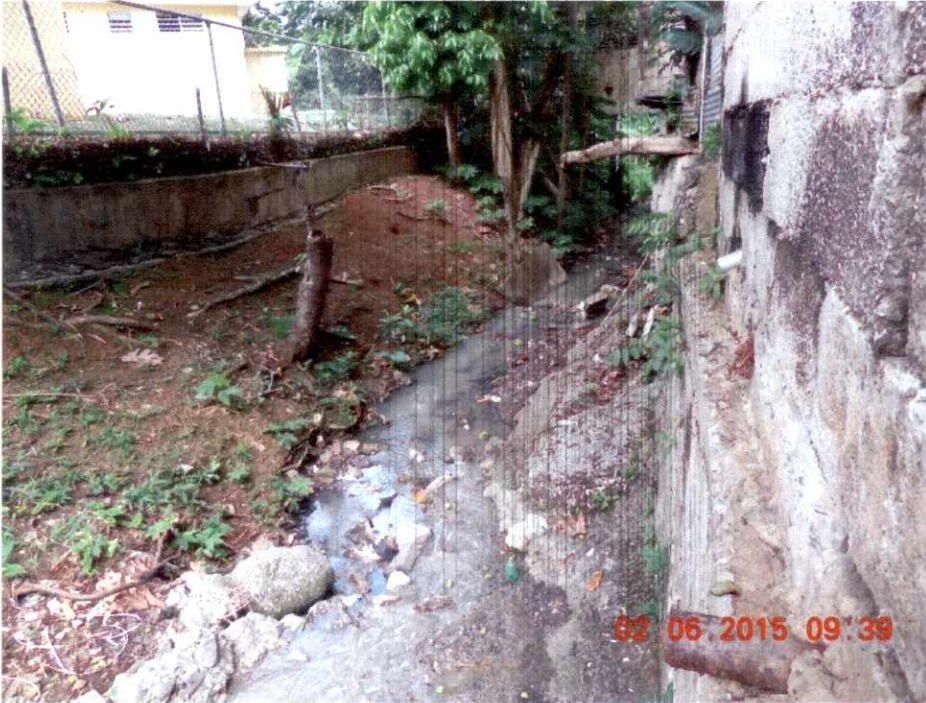
DSCN2233 – Additional view of an unnamed creek located north of Venezuela's Amalia Marín Public School and south of Guaracanal (PR-847) and Izcoa Díaz Streets intersection. Significant amount of flow with wastewater characteristics (e.g., color, odor, solids, and algae formation) was observed.

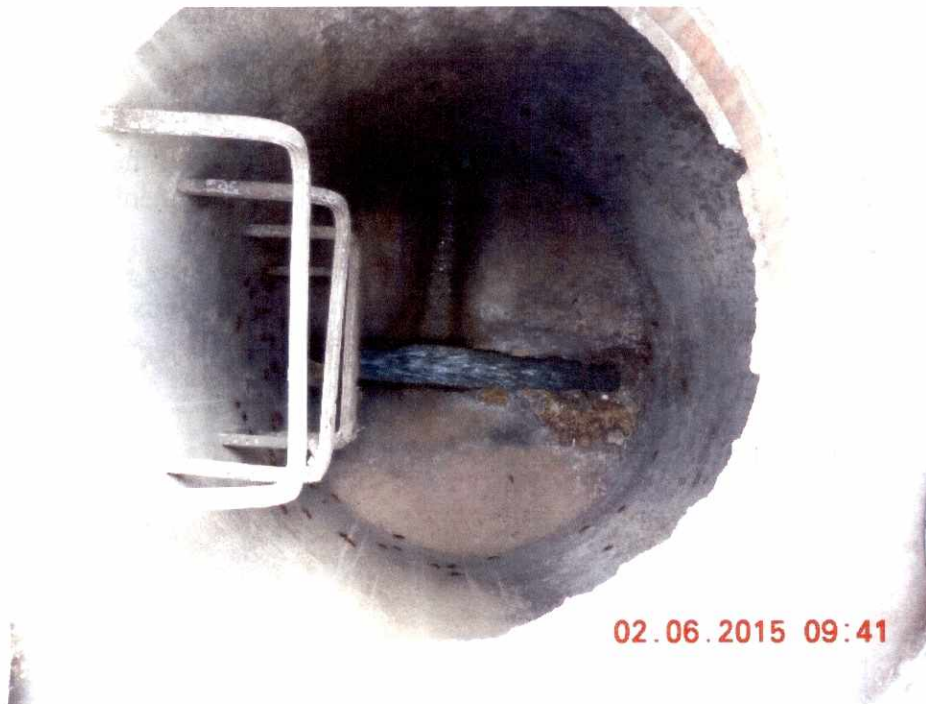
6. A wastewater manhole located at Guaracanal Street (PR-847), southeast of the wastewater discharge described in item 4, and in front of Amalia Marín Public School, was found flowing normally and in direction of Guaracanal (PR-847) and Izcoa Díaz Street intersection. Coordinates: Lat. 18° 23' 34.79" N – Long. 66° 3' 13.96" W. See photos DSCN2234 and DSCN2235 located in **Attachment I** for more details.

DSCN2234 – View of the inner part of a wastewater manhole located at Guaracanal Street (PR-847), southeast of the wastewater discharge into the unnamed creek, and in front of Amalia Marín Public School. The manhole was found flowing normally and in direction of Guaracanal (PR-847) and Izcoa Díaz Street intersection.

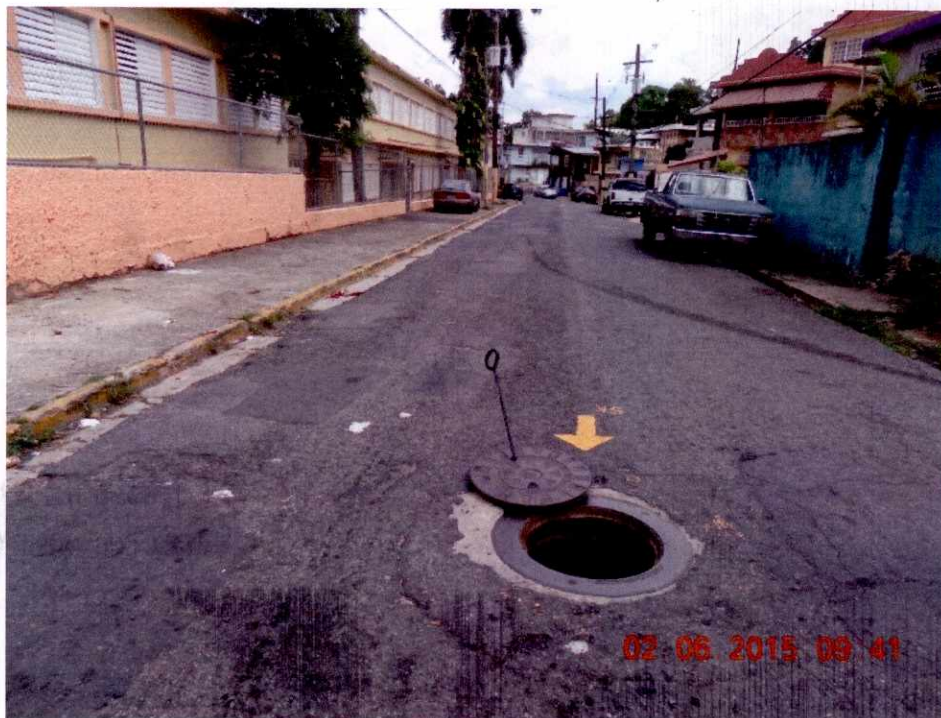
DSCN2235 – View of a wastewater manhole located at Guaracanal Street (PR-847), southeast of the wastewater discharge into the unnamed creek, and in front of Amalia Marín Public School. The manhole was found flowing normally and in direction of Guaracanal (PR-847) and Izcoa Díaz Street intersection.

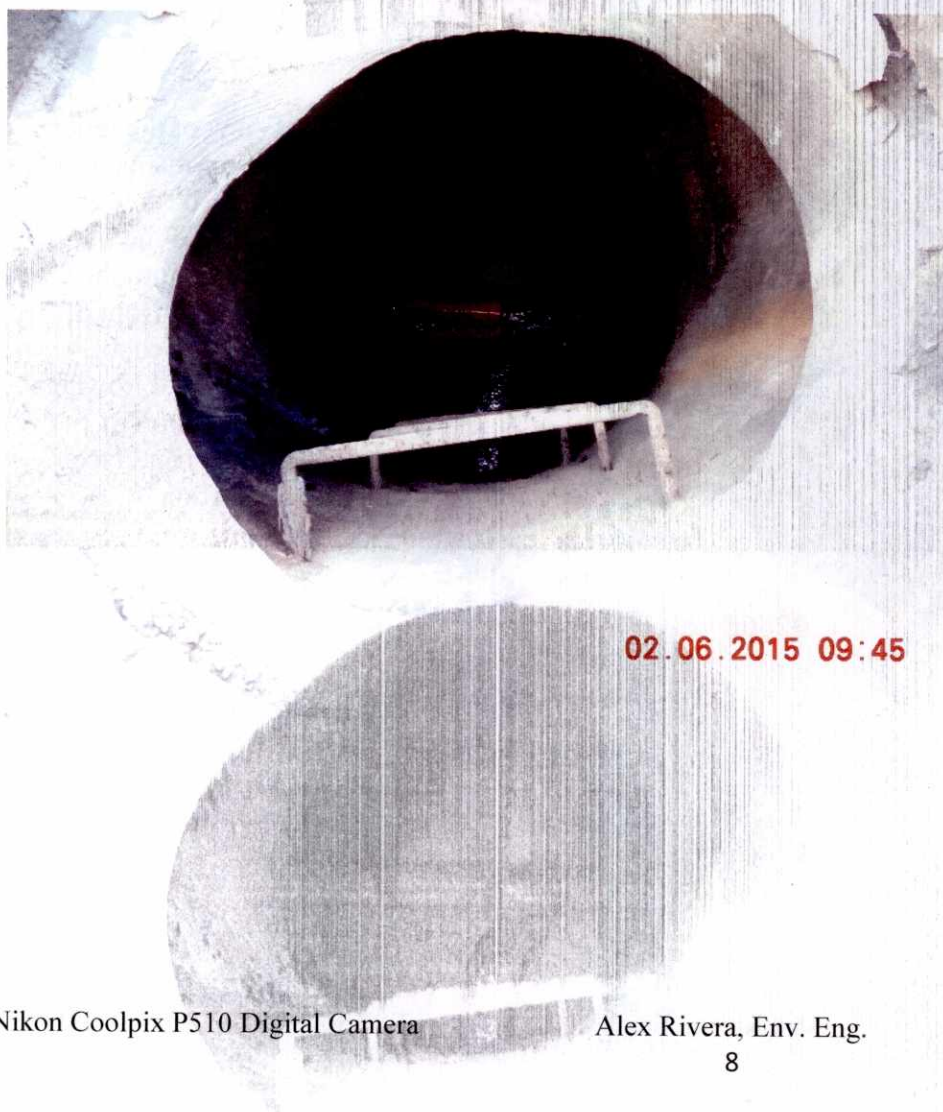
7. The wastewater collection system at Venezuela's Acueducto and Tanques Streets, parallel to Guaracanal (PR-847) Street was found flowing normally. See photos DSCN2236 to DSCN2239 located in **Attachment I** for more details.

DSCN2236 – View of the inner part of a wastewater manhole located at Venezuela Community Izcoa Díaz and Acueducto Streets intersection.

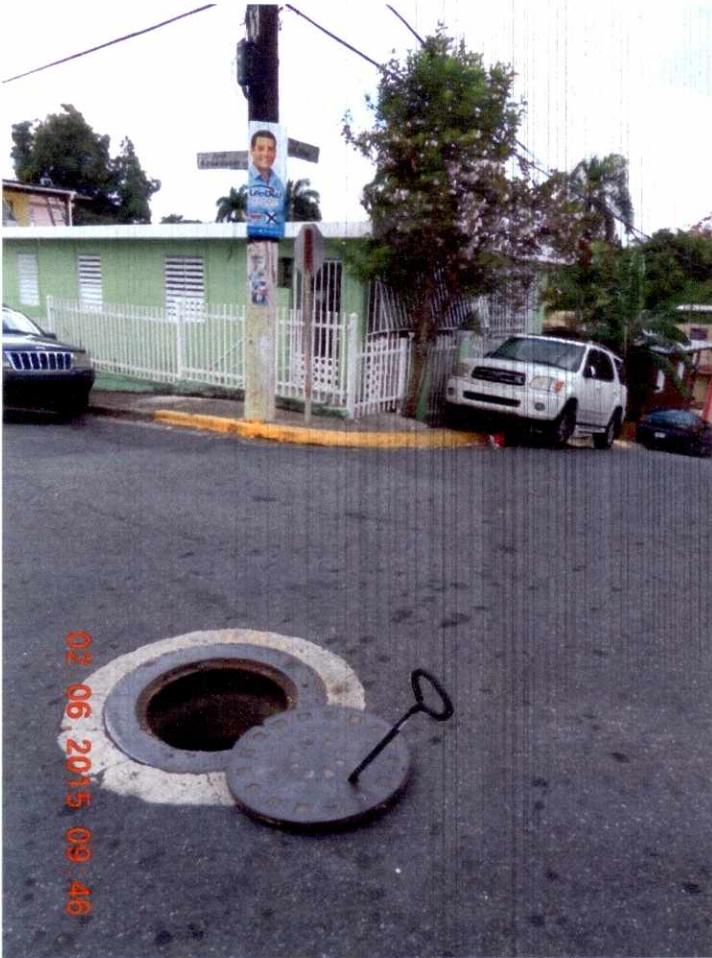
DSCN2237 – View of a wastewater manhole located at Venezuela Community Izcoa Díaz and Acueducto Streets intersection.

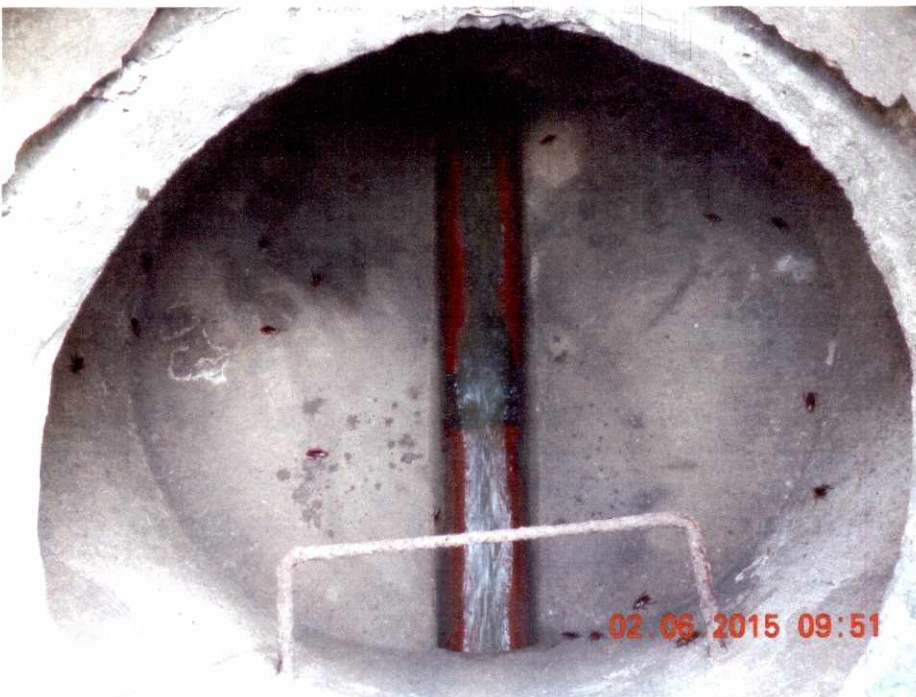
DSCN2238 – View of the inner part of a wastewater manhole located at Venezuela Community Acueducto Street.

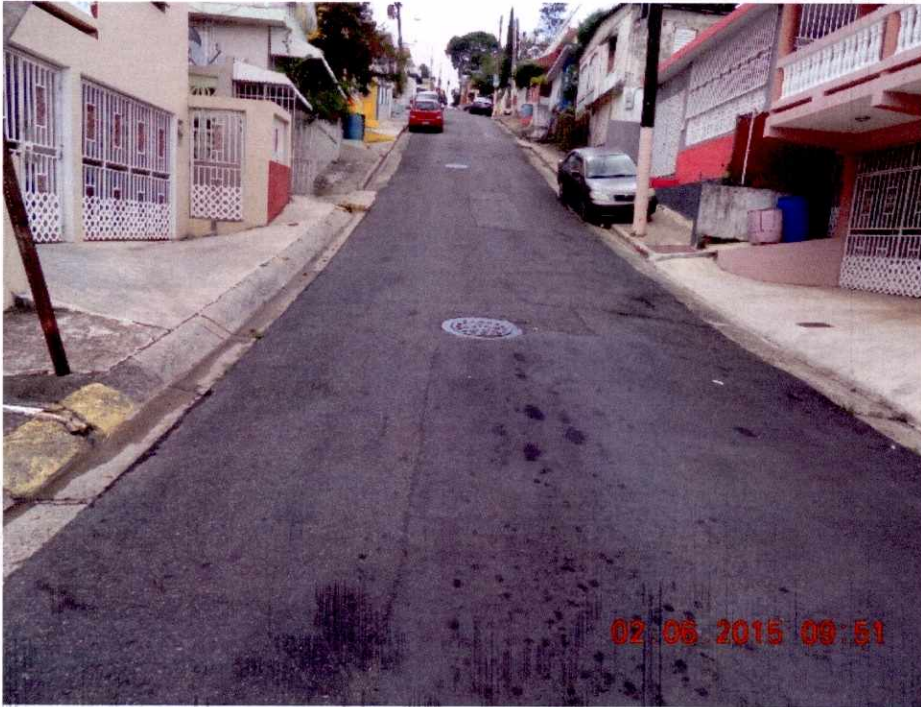
DSCN2239 – View of a wastewater manhole located at Venezuela Community Acueducto Street.

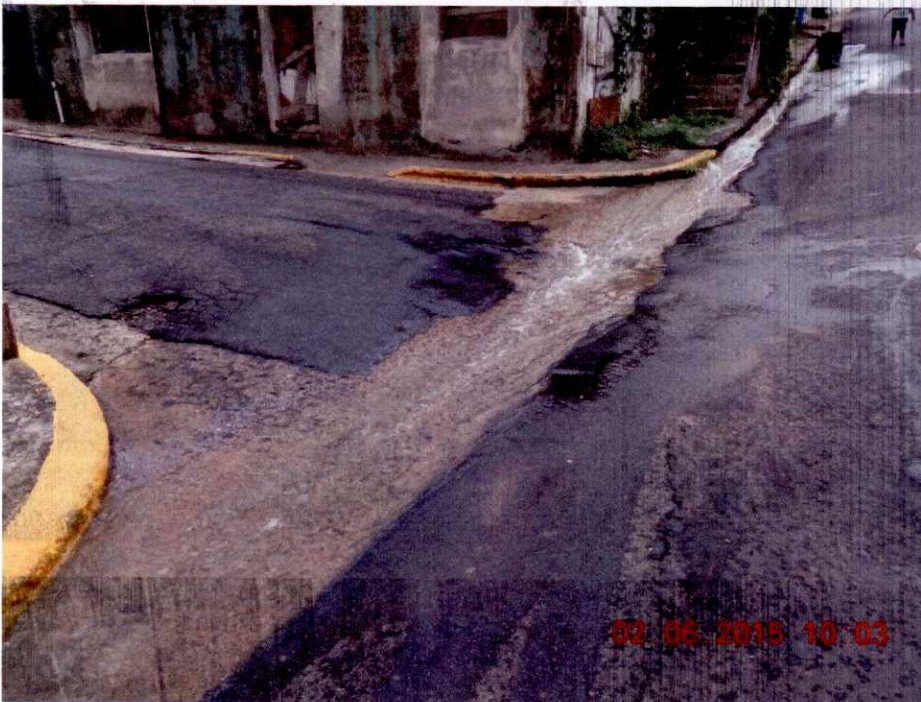
9. Large amount of drinking water were observed flowing into the stormwater sewer at Venezuela Brumbaugh Street. The flow was observed overflowing from the street near Brumbaugh and Callejón A Streets intersection. Coordinates: Lat. 18° 23' 42.44" N – Long. 66° 3' 9.50" W. The situation was also informed to PRASA's Christie Mota by the EPA inspector during the June 2, 2015 10:01 AM telephone conversation. See photos DSCN2240 and DSCN2241 located in **Attachment I** for more details.

DSCN2240 – View of an apparent drinking water broken line causing a large discharge into the stormwater sewer at Venezuela Brumbaugh Street. The flow was observed near Brumbaugh and Callejón A Streets intersection.

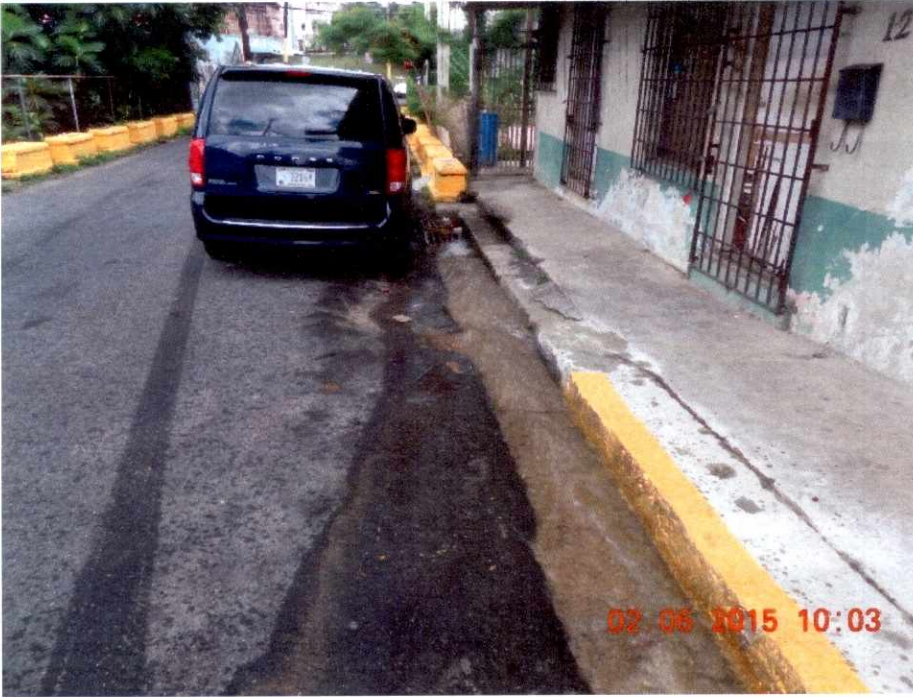
DSCN2241 – Additional view of an apparent drinking water broken line causing a large discharge into the stormwater sewer at Venezuela Brumbaugh Street. The flow was observed near Brumbaugh and Callejón A Streets intersection.
